Abandoned Railway Station BhoeAsal –Reverberation from 1945

Abstract

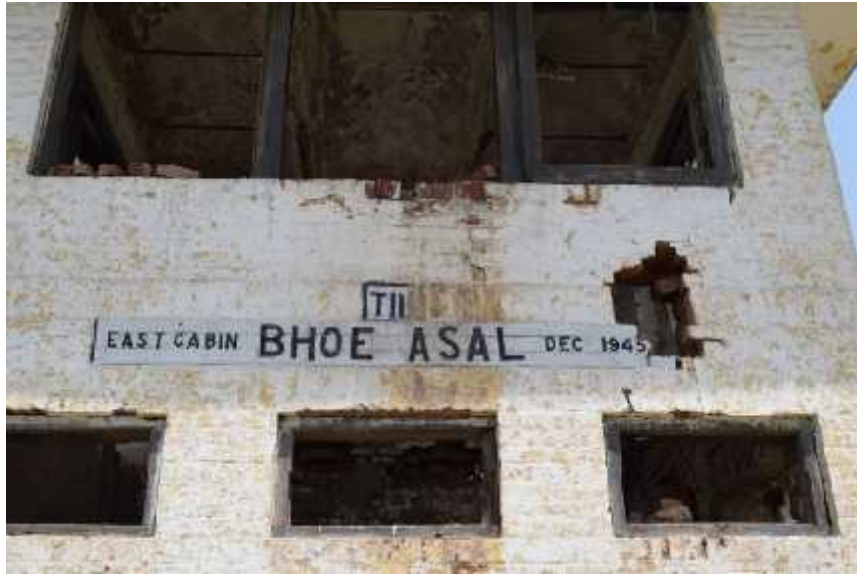
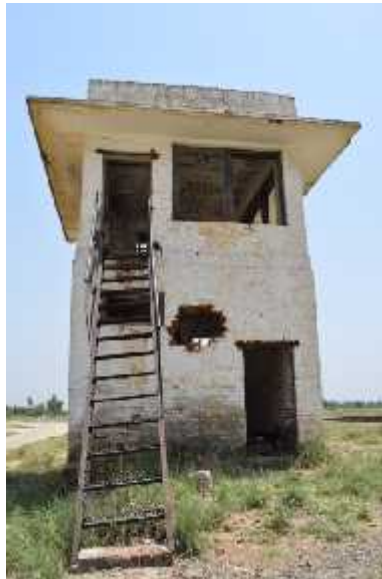
Plate.3 Signal Cabin. Doors, Windows, Ventilators and Stairs.

Dilapidated structure of East Signal Cabin is another prominent structure standing alone across the railway lines.(Plate.3) In good days this signal cabin was equipped with mechanical interlocking system for TII. Traditionally designed signal cabin in two levels has reduced to rubble. Upper level windows and lower level ventilators are disappeared only the openings with tattered wooden frames in the walls witness their existence in the structure. Access to lower and upper level is from south side of the cabin. A 15 steps metal stair leads to the upper level that has lost half of its metal railing whereas entrance to the lower level room was once through a door which is now just an opening of 198cm x 91cm. Total constructed area of signal cabin from ground is 524cm x 433cm with an extended roof.

Structure of signal cabin is constructed with bricks, further painted with yellow and over layered additional with white wash. Chipped of paint clearly shows these layers. Main façade of signal cabin on eastern side shows written information about the station mentioning East Cabin BhoeAsal, Dec 1945, in one line and above this line is written TII which is the indication of Traffic Type. North western walls of the structure are symmetrically divided for windows and ventilators suggested by the existing openings, though the ventilators of west wall are filled with bricks perhaps to prevent from wind or dust to come from west.

Dilapidated condition of the building of signal cabin is putting a depressing impact on the visual amenity of its surroundings. Significant damage has occurred to exterior as well as interior of this structure. The wooden roof dividing whole space of cabin in two levels is completely disappeared. It may have been shifted to reuse for some other stations, stated by D.G. Vigilant, Captain Asif Ali. Further he stated, 'when a station is closed all the reusable items are taken off from the station or station building and either reused for other stations in

Upper level of the signal cabin has two remains of old days when station was working. One, a fire place with a triangular concrete extension and the other is wooden ET phone board still hung on the north wall. The floor of upper cabin is always built with wooden logs within which mechanical interlocking system is fixed for function. These wooden logs can be easily replaced that is why the complete structure of the wooden floor has been removed from this cabin. Signal cabin is located, elevated and built in such a way that enables to have a good view of signal, points and lines from there. Signal post and bracketed Home signal can be clearly viewed from windows.

Another important feature of signal cabin that remains is a horizontally fixed steel beam in the east wall. This beam retains the load of walls above the running interlocking mechanism of point rodding that passes through an opening under this beam. The mechanical interlocking system is further attached with the railway lines for changing points. Levers of mechanical interlocking are operated from upper level and the rods run through lower level of signal cabin and pass through the wall on ground. That is why; lower level of signal cabin is kept clean so nothing disturbs the mechanism installed while operation.

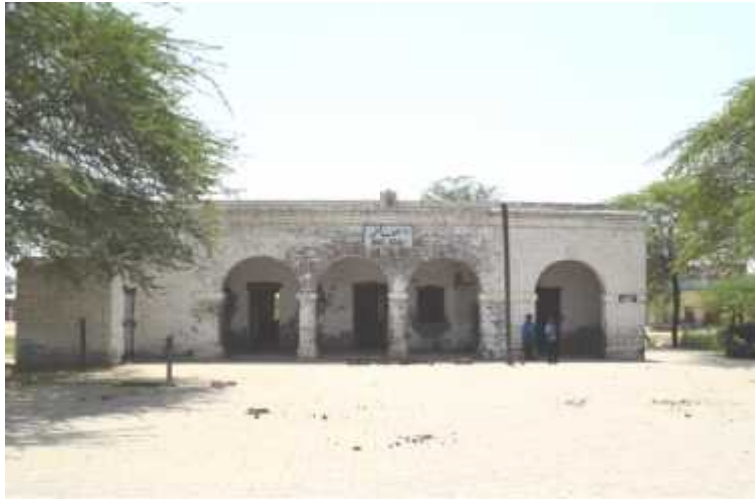
Plate.4 BhoelAsal Station Building..

In the center of the platform exists historical station building with five rooms according to their function. (Plate.4) These rooms are accessed through a veranda of five round arches. Right side arch is set on walls on both sides rather pillars. The width of walls is used for benches constructed with bricks. Veranda is divided by a wall in between booking office and waiting room generating enough space on both sides to construct benches with walls. Level of the station building is eight centimeter raised from the level of platform. The total area of station building is 16 x9 meters. Like other B-Class stations, Bhoehasal station building is comprised of station master room, assistant station master room, store or parcel room, booking or ticket collection room and waiting room. Facing station building room on the extreme right was waiting room. Next to that was booking office. Next to booking office the room is divided into two sections these sections were meant for the booking of luggage and parcels. And the room on left end was the room of station master.¹⁵ Façade of the station shows two texts written in black on white washed surface. One text mentioning the name of the station, Bhoehasal in Urdu and English and TI,¹⁶ whilst the other mentioning VTP (vision testing point). Both of these are mandatory information provided in every station.

Interior of all the rooms is in dreadful condition due to the damages occurred with negligence and by removing items, from the structures. Some of the windows and doors are missing from these rooms. Decrepit condition of these rooms is telling a story of its memorable past. Window of booking office and a wooden projection (may be a shelf) fixed with wall in same room narrates the story of its past.

On the left end of the station building is an extended structure of toilet. It has one door facing south and a ventilator in the wall facing north. Toilet is facilitated with a well planned sewerage system. Drain from toilet is falling in a gutter from where another drain letting the water goes out from gutter into main drain. A water spout from the roof of this toilet is also falling in same main drain. Outside to toilet is fixed a hand pump which is out of order now and many of its parts are missing. Defacement and damages have turned the whole structure of station building in the state of desolation.
